AG-MI-2014-03-B-EN – Pre-Rotator Bendix Gear

MTOsport, Calidus and Cavalon before Date of Manufacture (DOM) 2014

Inspect configuration state of bendix shaft and replace with improved version, if required.

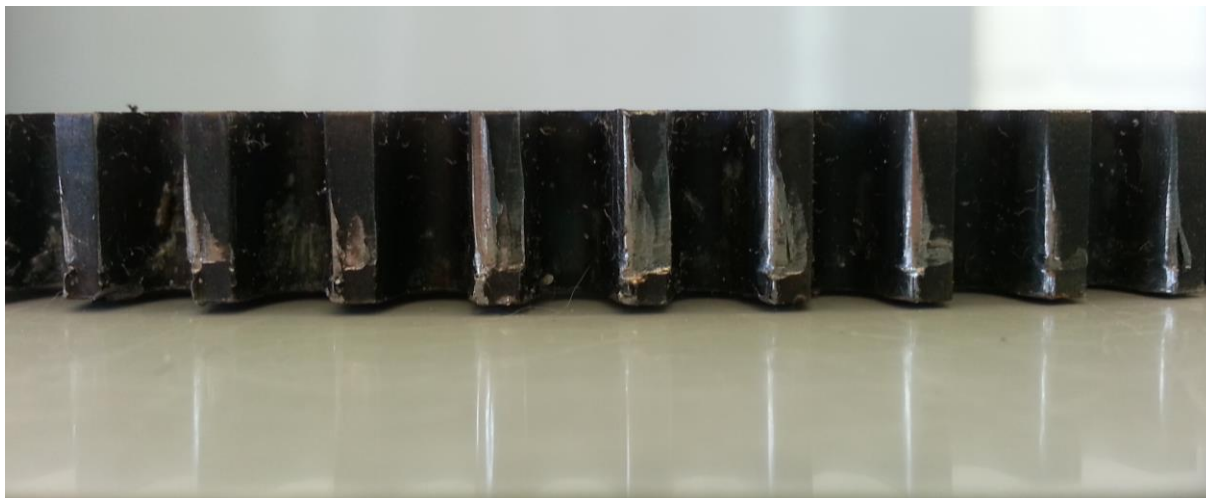
- 1 Inspect wear pattern and gear mesh of pre-rotator upper engagement.
- 2 If the wear pattern is uneven (see Fig. 1 / eg due to dynamic skew), the position of the bendix shaft must be inspected. Remove lower bearing and ensure that the shaft is, in free load condition, centrally positioned in the bearing seating. If free play in the upper bearing is present, the following must be carried out:

Fig. 1 - Wear Pattern (uneven)

- 3 **Free play through bearing abrasion:**
Replace upper bearing and glue bendix shaft with Loctite 638 (high strength / AG-BAS-04) into the upper bearing. Reassemble lower bearing.

- 4 **Play through abrasion of the bendix shaft from ball bearing inner ring:**
Glue bendix shaft with Loctite 638 (high strength / AG-BAS-04) into upper bearing. Reassemble lower bearing. If free play is greater than 1/10 mm, then replace bendix shaft with new part and glue new part with Loctite 638 (high strength / AG-BAS-04) into upper bearing. Reassemble lower bearing.
